**NATIONAL TRANSPORTATION SAFETY BOARD
WASHINGTON, D.C.**

FIRE AND EXPLOSION GROUPS FACTUAL REPORT

**Appendix III
(Tests and Study)
(81 pages)**

TWA FLIGHT 800 ACCIDENT INVESTIGATION

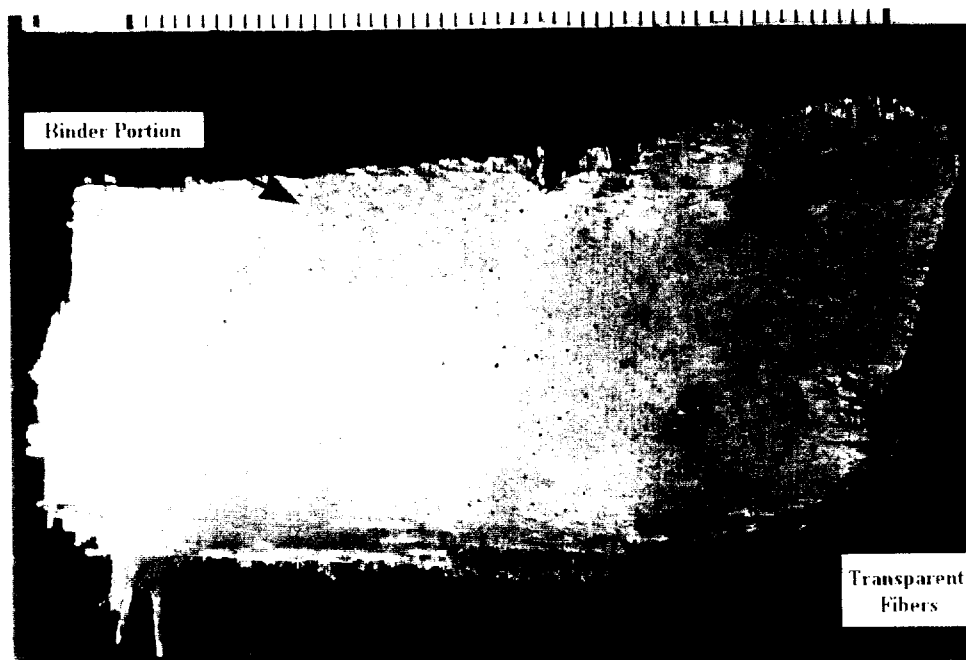
- 3.2.2 Initial examination of the duct debris (Figure 5) by optical microscopy, indicated the material consisted of translucent fibers which were predominately inorganic and a binder which was an organic based material. The IR analysis identified the major component of the binder as a flame retardant polyester resin (Figure 6). The fibers were examined by elemental analysis.

Figure 5: Duct Material from MMB-1

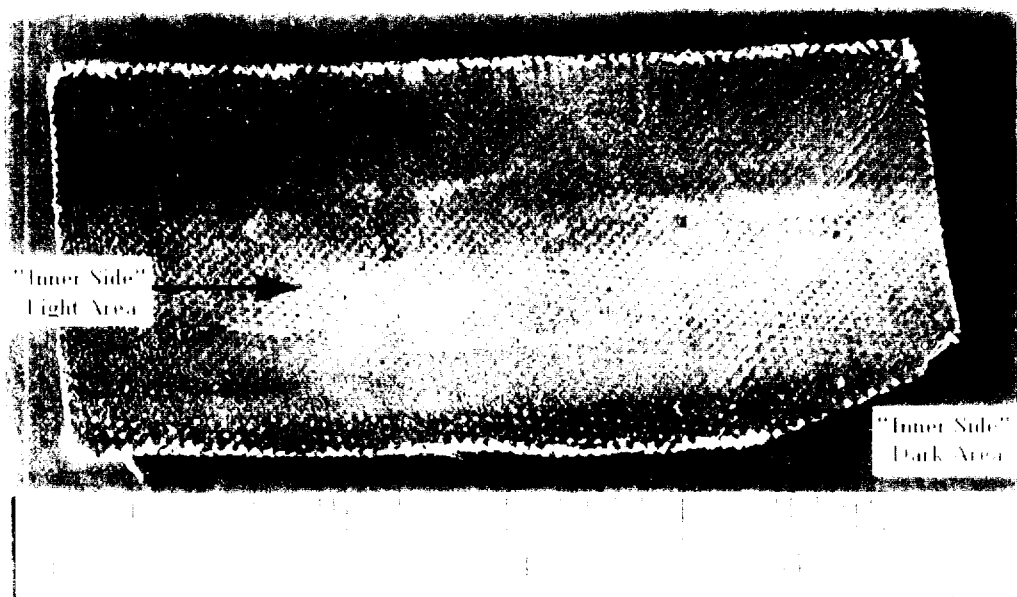
Figure 5: Overview of "Inner Side"

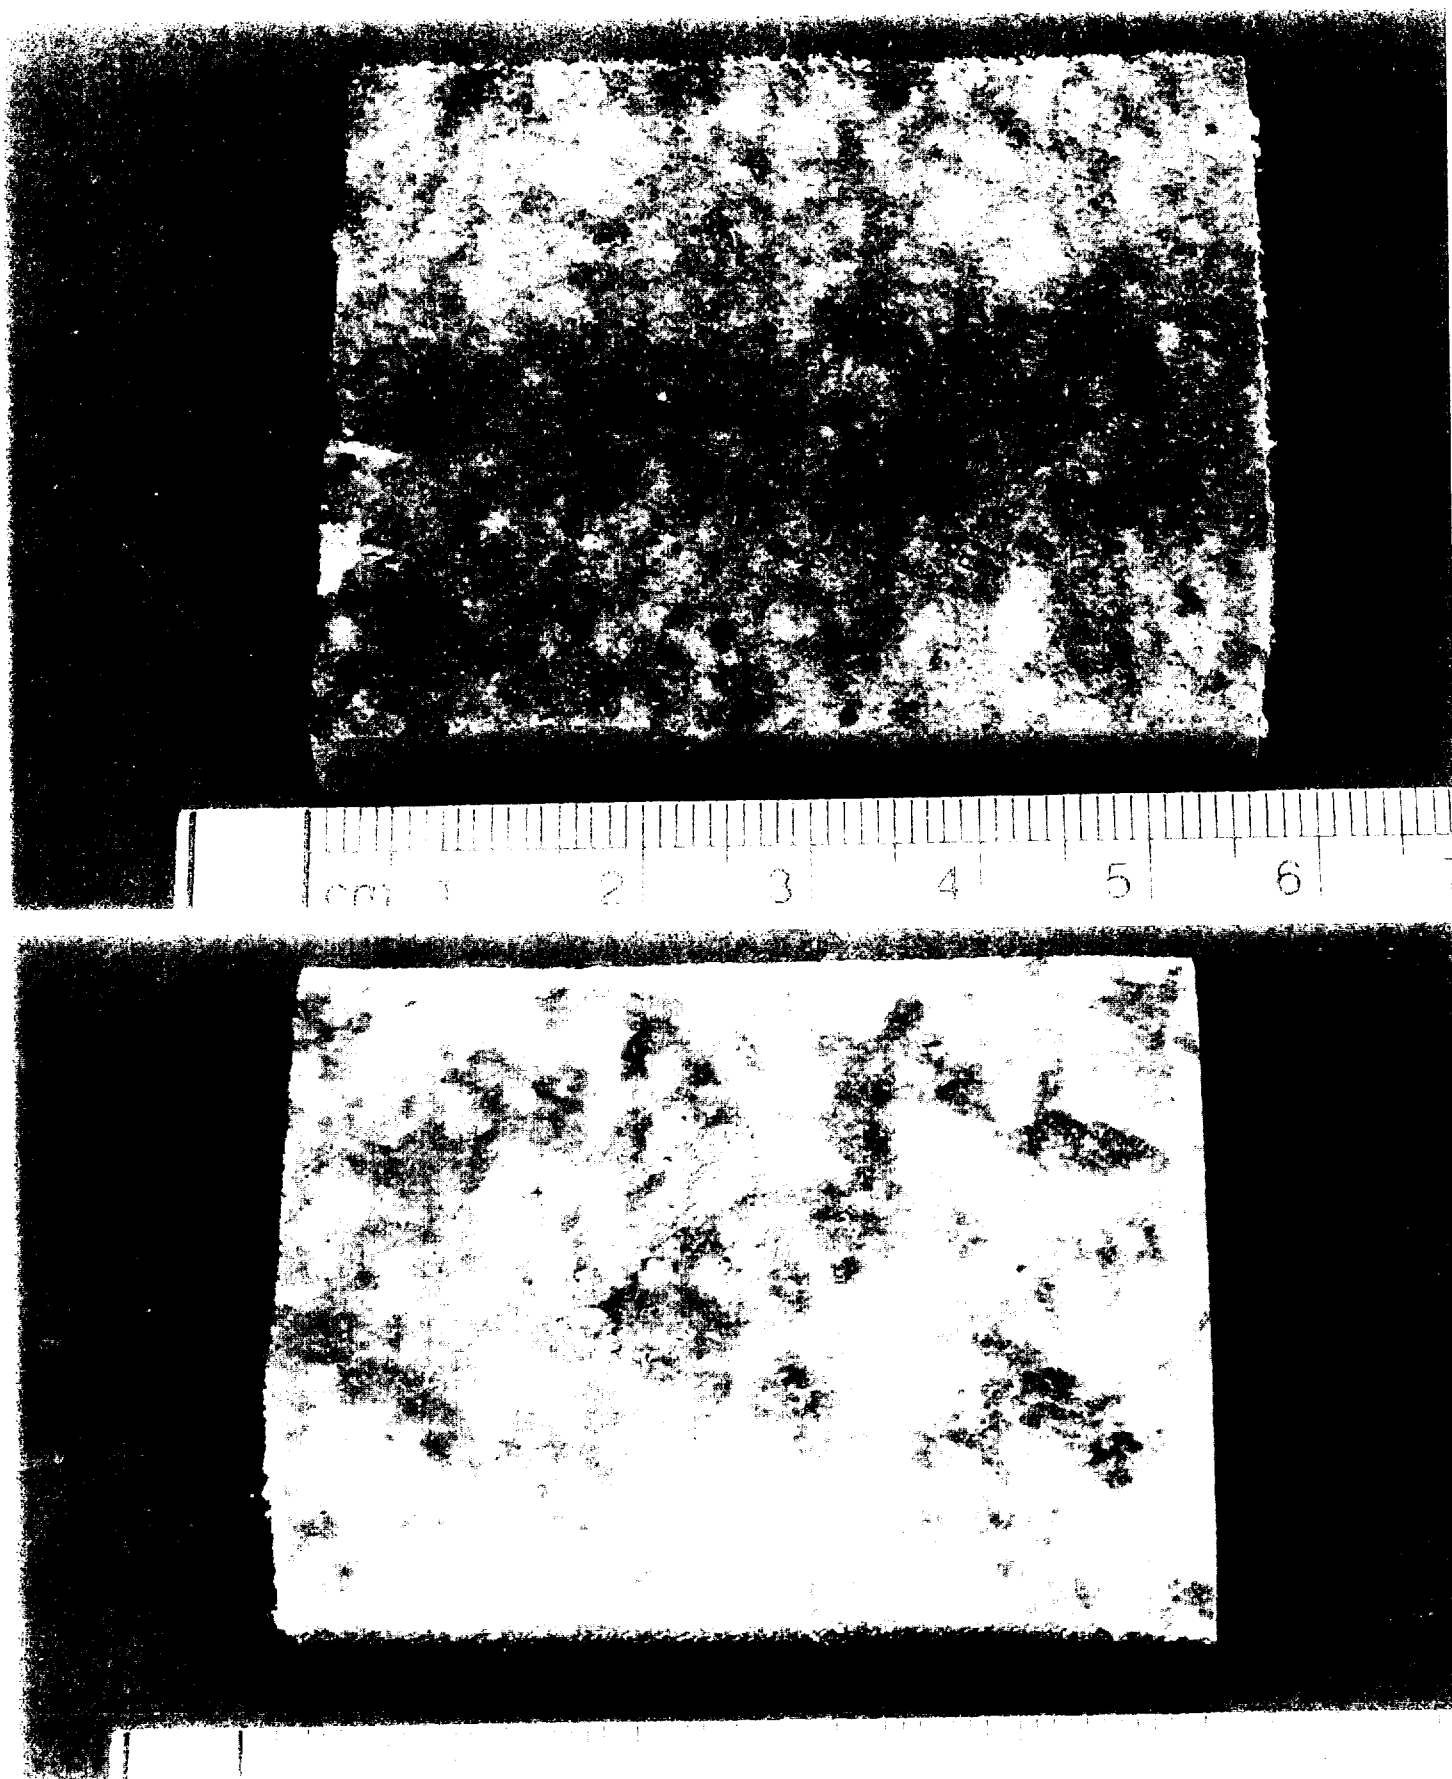
- 4.2 The IR data suggests that the flexible foam in sample #67, is consistent with a closed-cell, plasticized polyvinyl chloride (PVC) foam containing a nitrile rubber. Further evidence suggests that the red material found on both sides of the foam is the same. The unknown red material is characteristic of a resorcinol based, two-part room temperature curing adhesive containing a high concentration of a dye much like an orange cobalt complex azo dye. Use in dyes, pharmaceuticals and as a cross-linking agent for NeopreneTM are some of the applications of resorcinol products.

Figure 1. Sample #67, Row #19, Seat #2 Heavy and light coated sides.

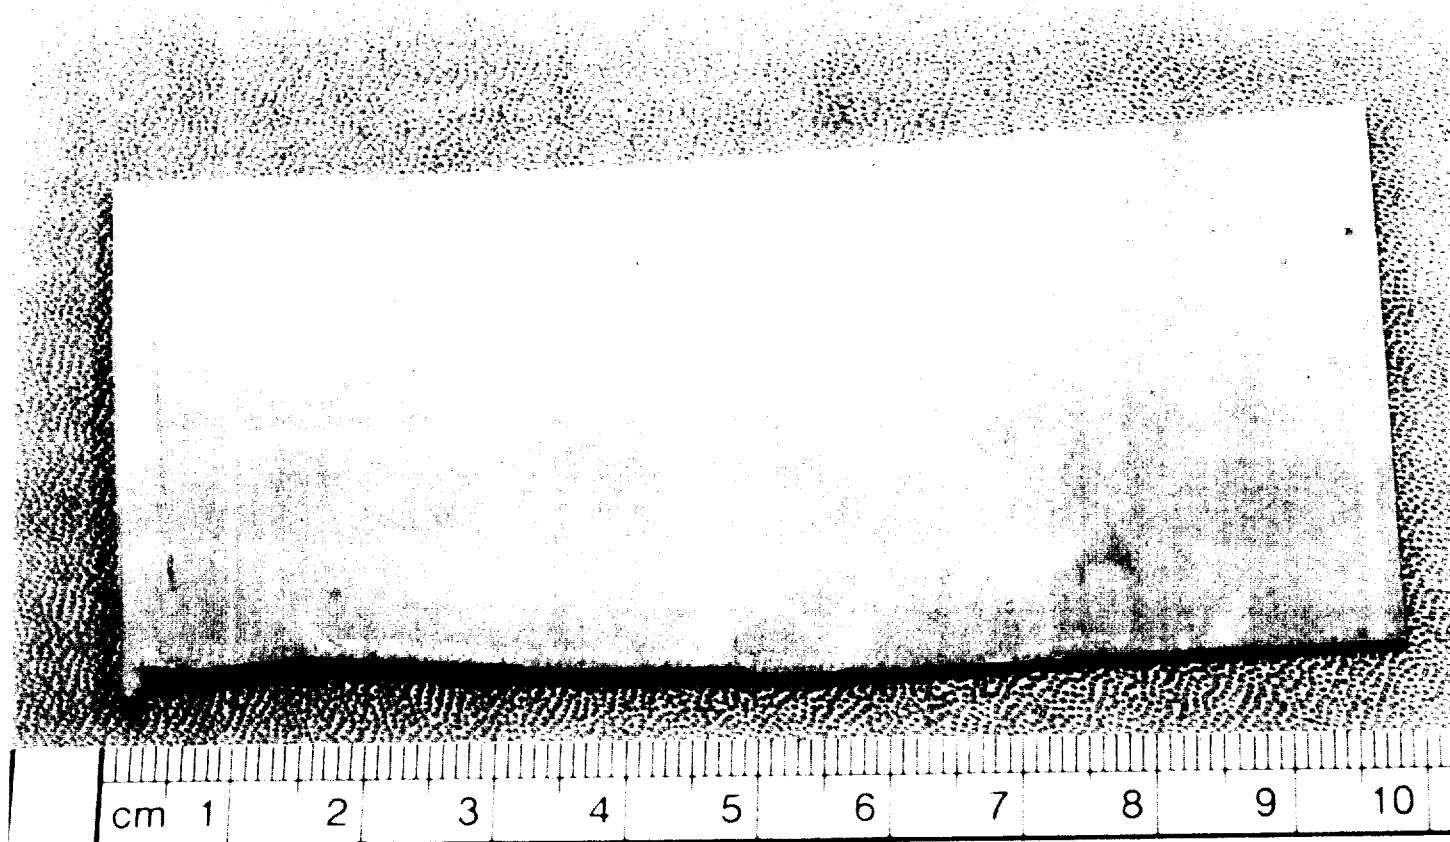
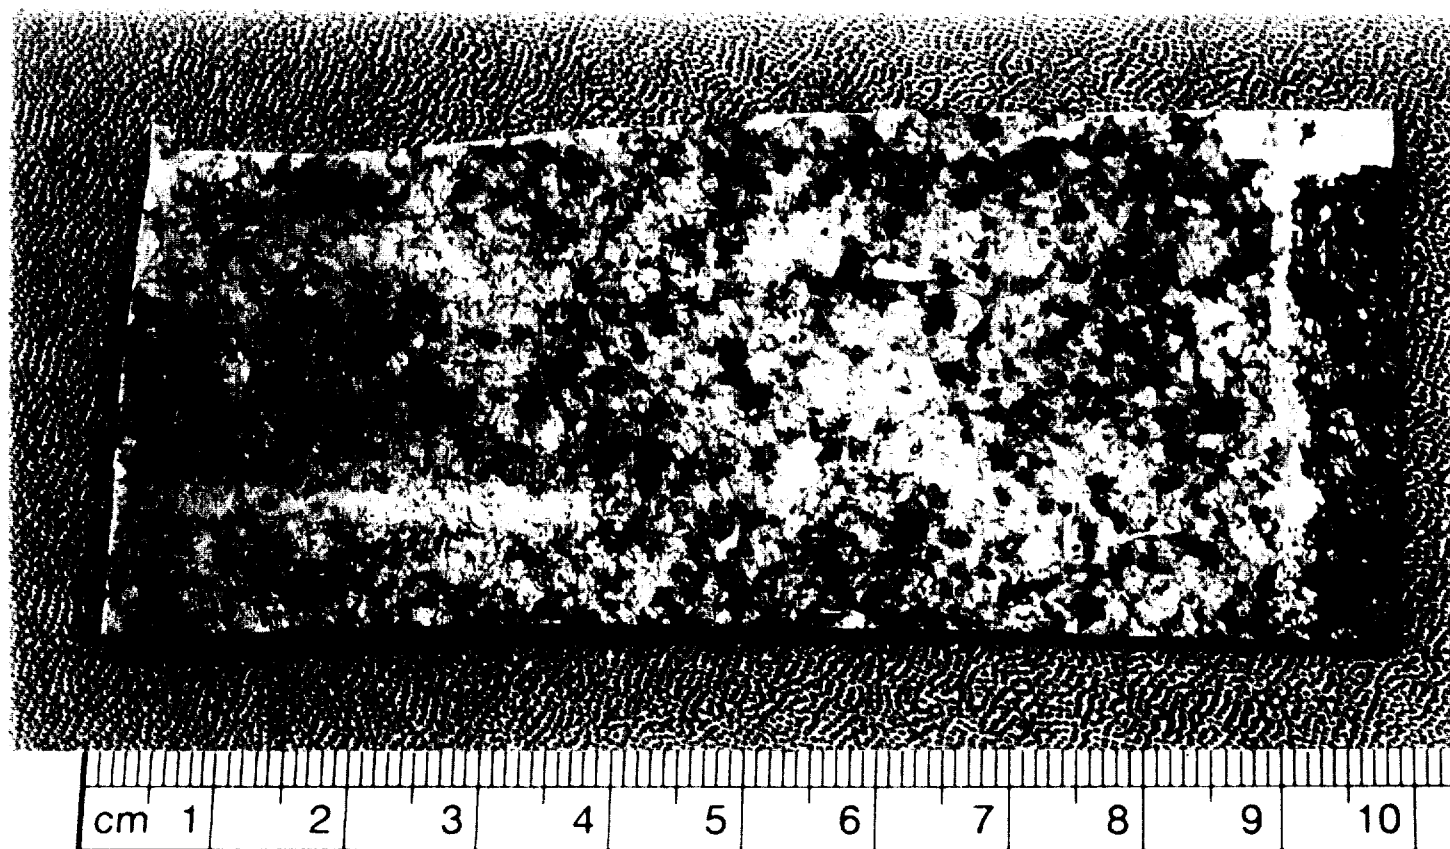
Figure 7. Sample #70, Row #17, Seat #8.

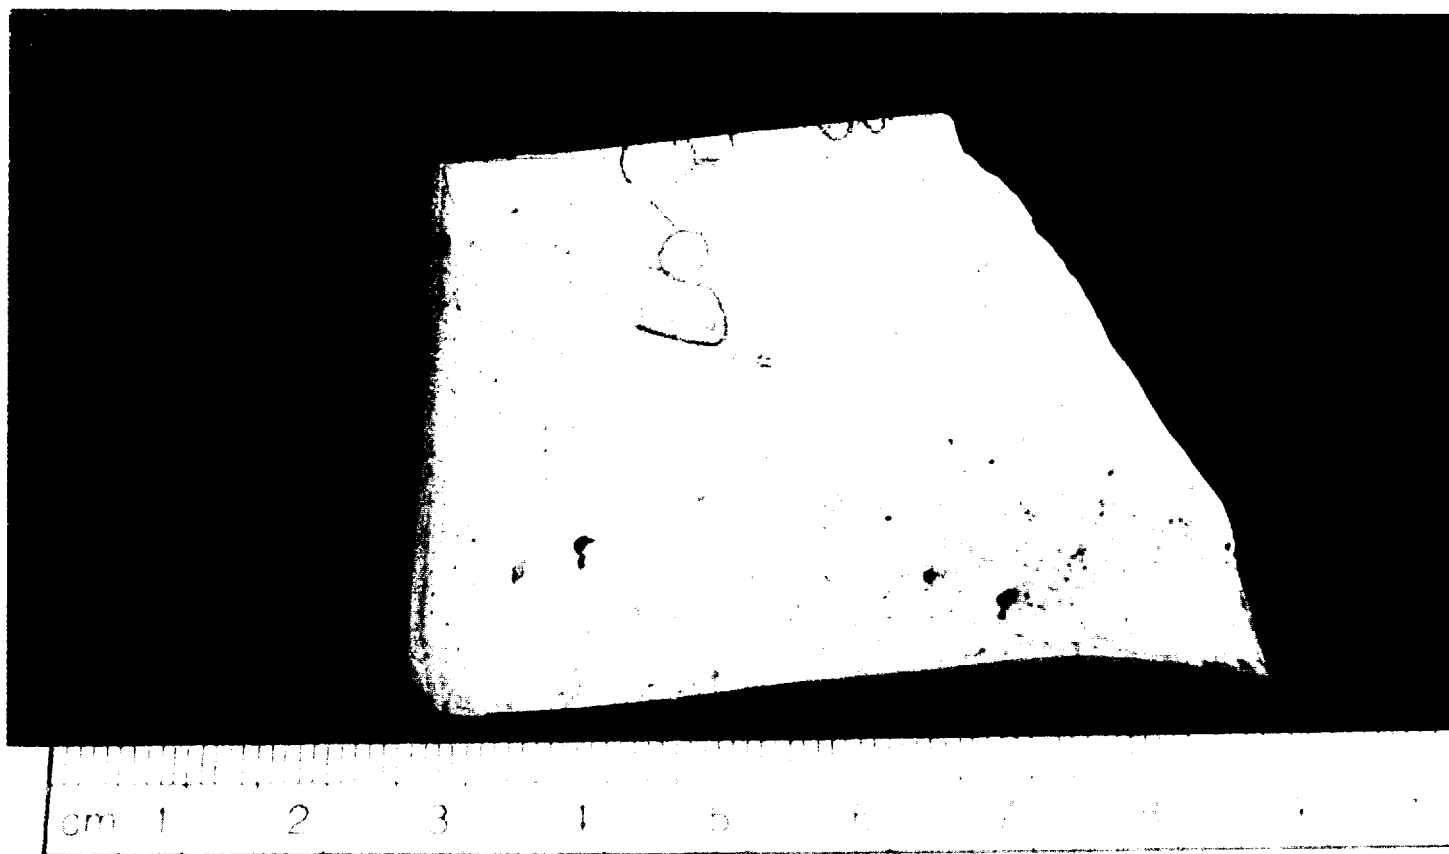
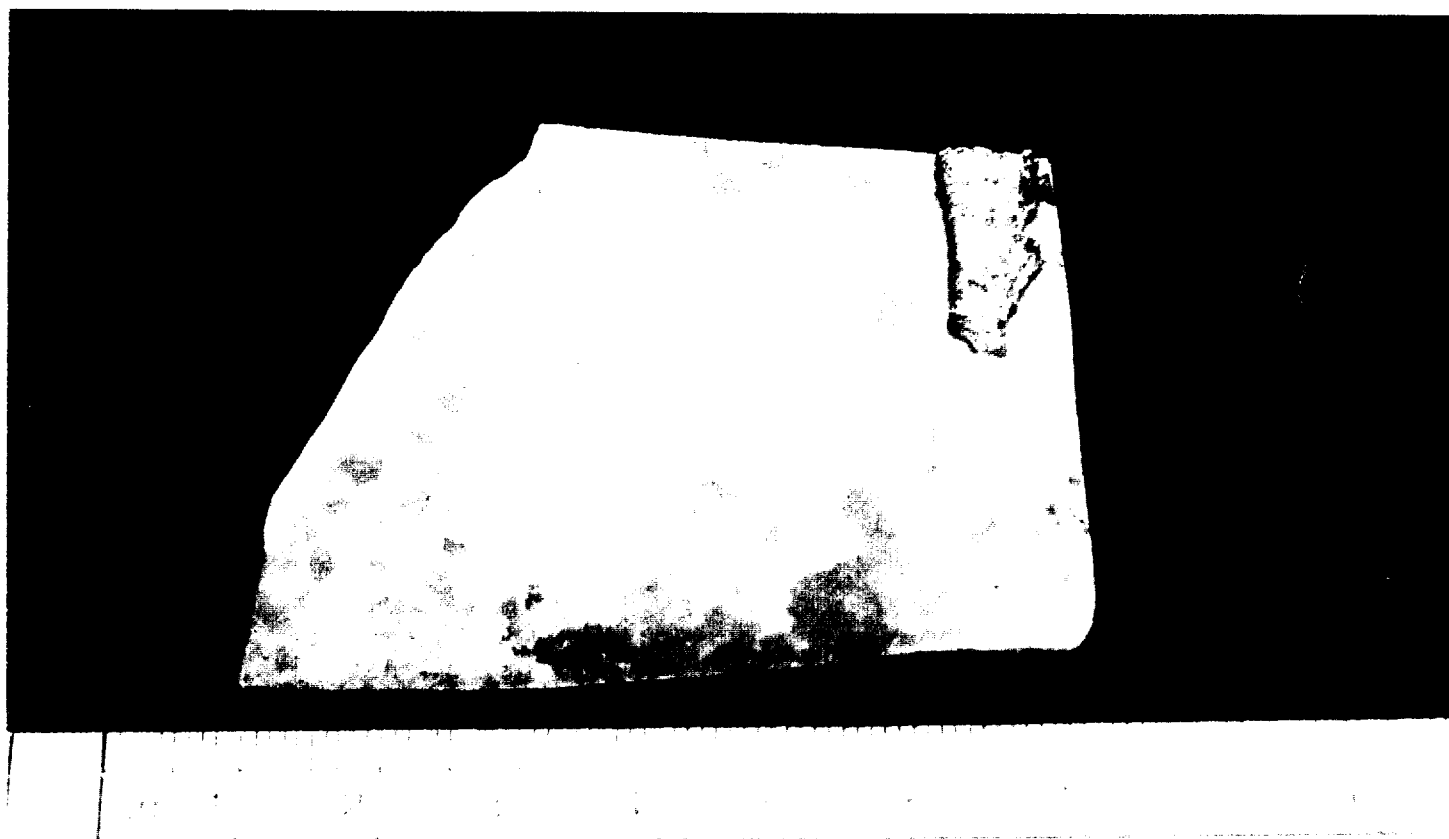
Figure 12. Sample #73, Row #27, Seat #2.
